Supplementary Material for "BEAF: Observing BEfore-AFter Changes to Evaluate Hallucination in Vision-language Models"

Moon Ye-Bin¹*⁽⁰⁾ Nam Hyeon-Woo¹*⁽⁰⁾ Wonseok Choi²⁽⁰⁾ Tae-Hyun Oh^{1,2,3}⁽⁰⁾

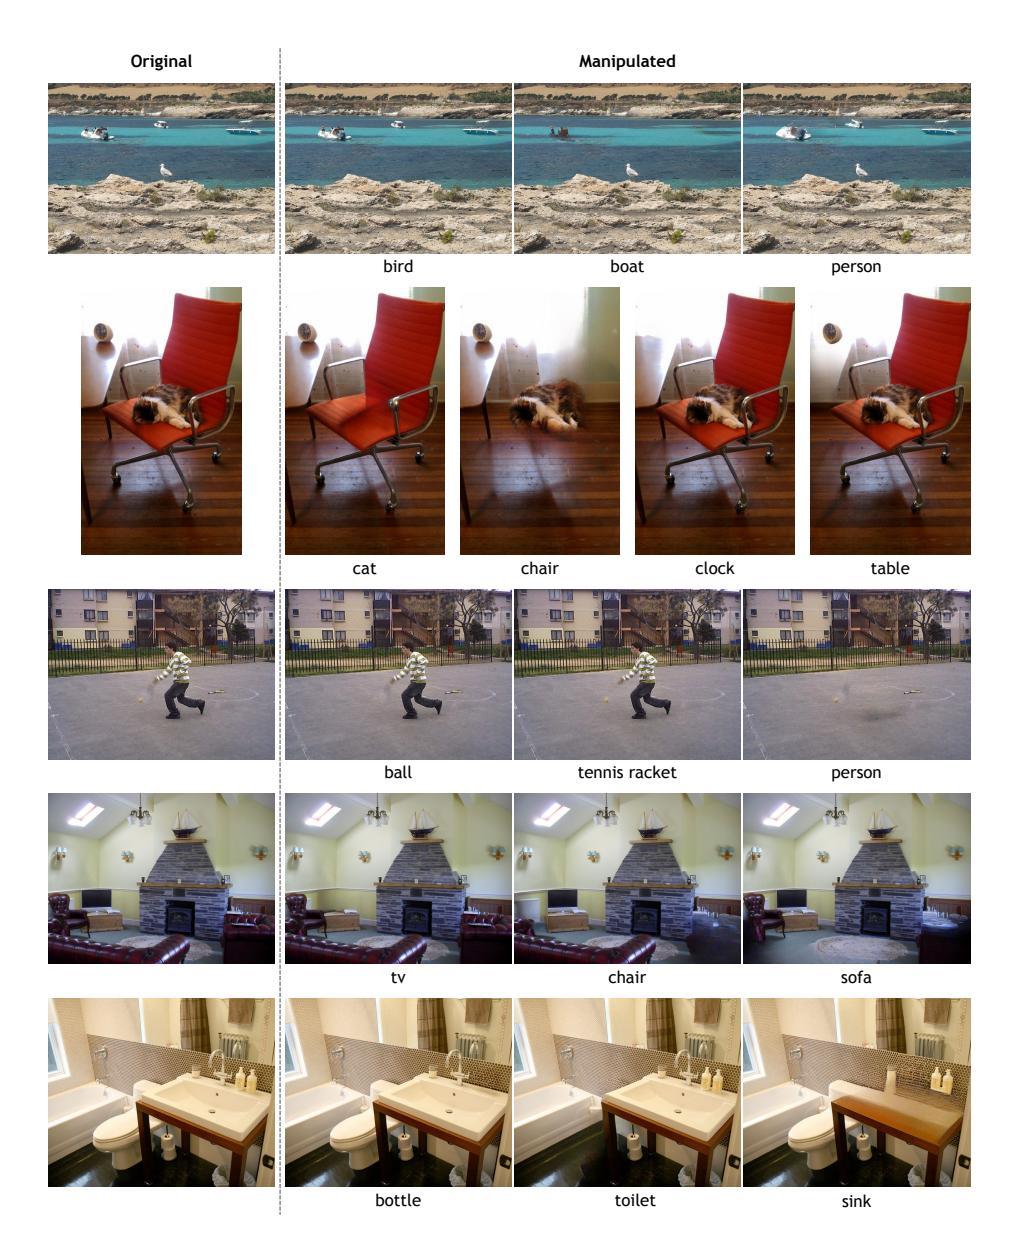
Fig. S3: Samples of the original and manipulated images in the BEAF dataset. We visualize sample images in our BEAF dataset. The first column contains original images, and the rest of the columns contain manipulated images. The removed object is noted below each image.

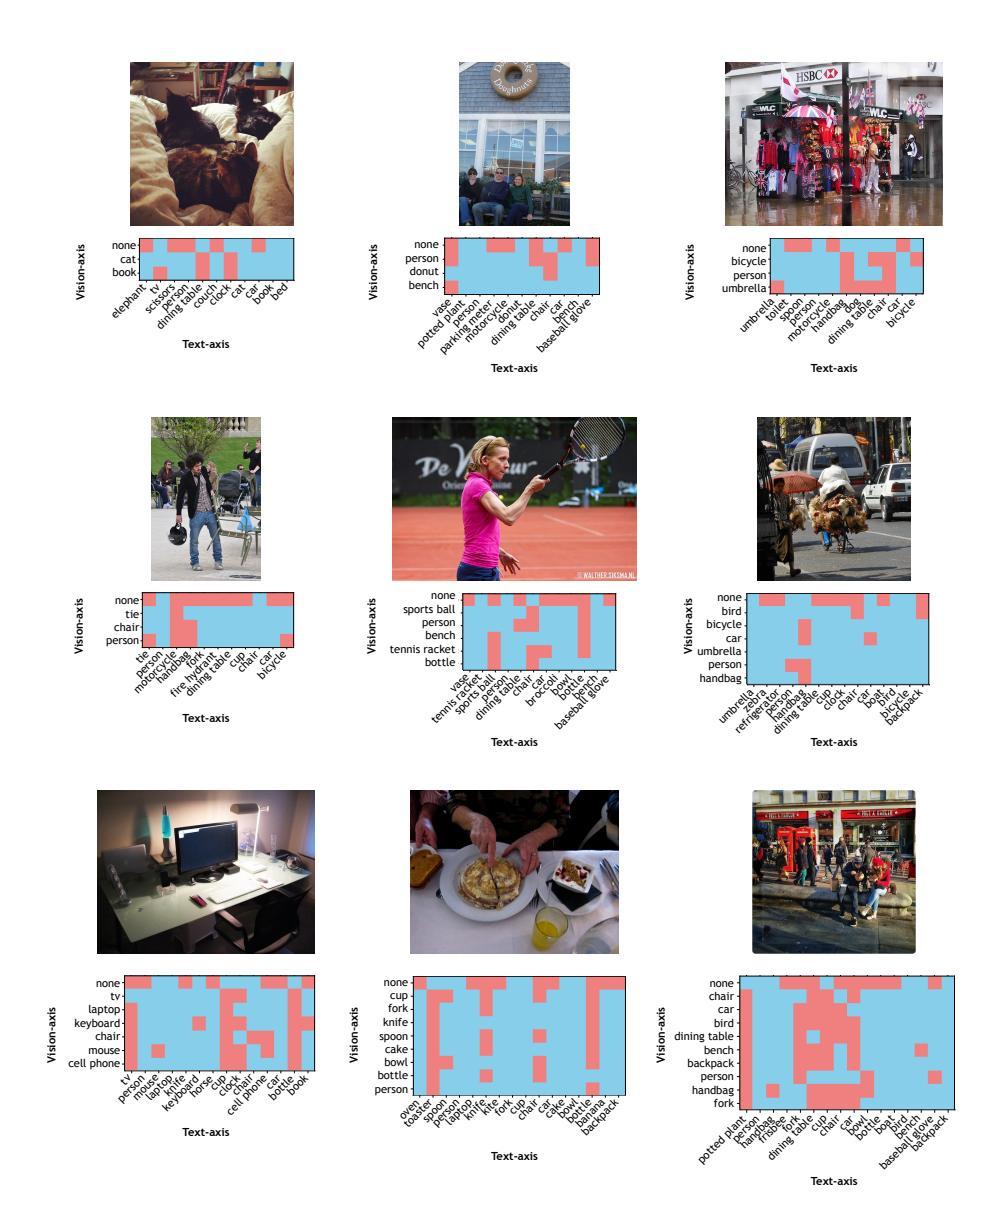
Fig. S4: Visualization of image-wise object relationship. We visualize the original images and the corresponding object relationship with the text (x-axis) and vision (y-axis) axes. We color the correct answer blue and the wrong one red. For example, a heatmap entirely in blue indicates that the answers to all questions are correct. On the text axis, the objects represent the questions posed, whereas, on the vision axis, they correspond to the objects manipulated in the image. The "none" on the vision axis means the original image, *i.e.*, none of the objects is removed. This approach allows us to analyze the influences between objects within a scene simultaneously.

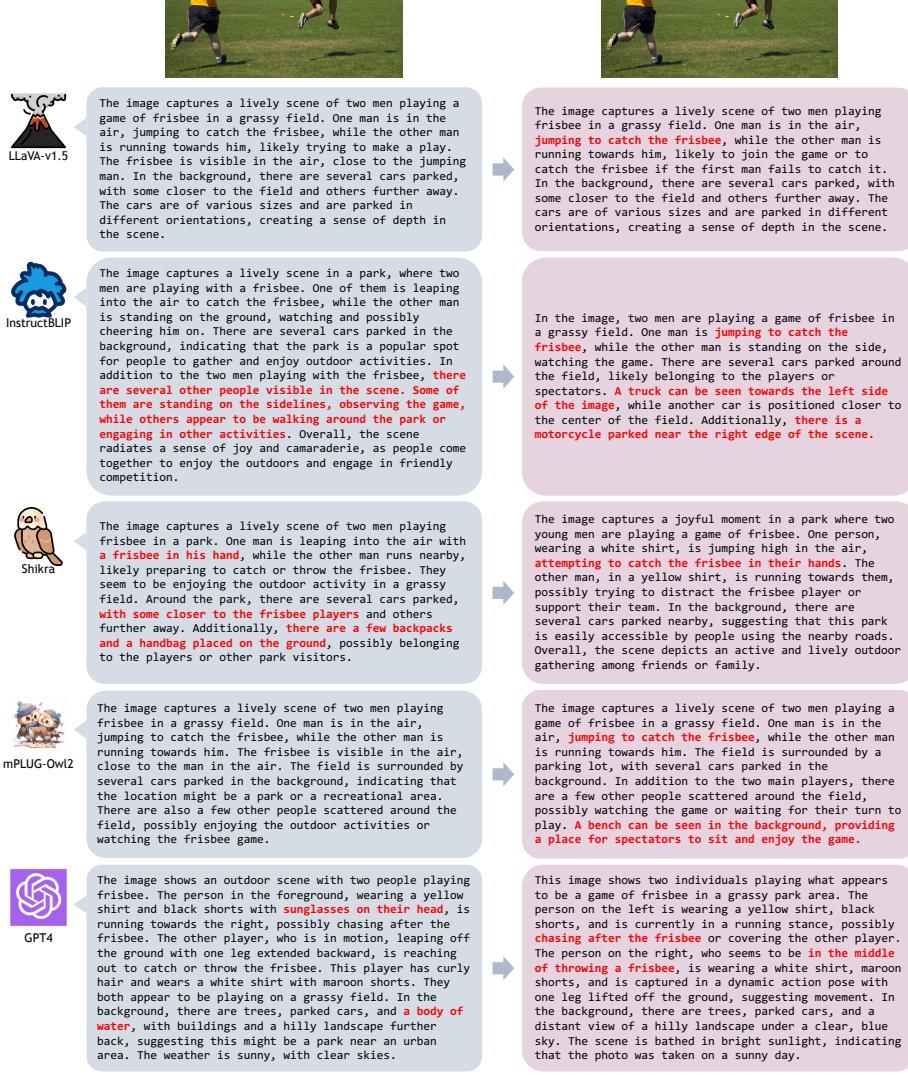
Fig. S9: Additional qualitative example (4) on open-ended generation task. In this example, the frisbee is removed.
